E1551.05-113-11-R0
ACOUSTICAL PERFORMANCE TEST REPORT
ASTM E 90, ASTM E 492, ASTM E 2179

Series/Model: 10 mm Regupol Sonus Rubber Underlayment

Specimen Type: Floor/Ceiling Assembly

STC	53
IIC	50
ΔIIC	20

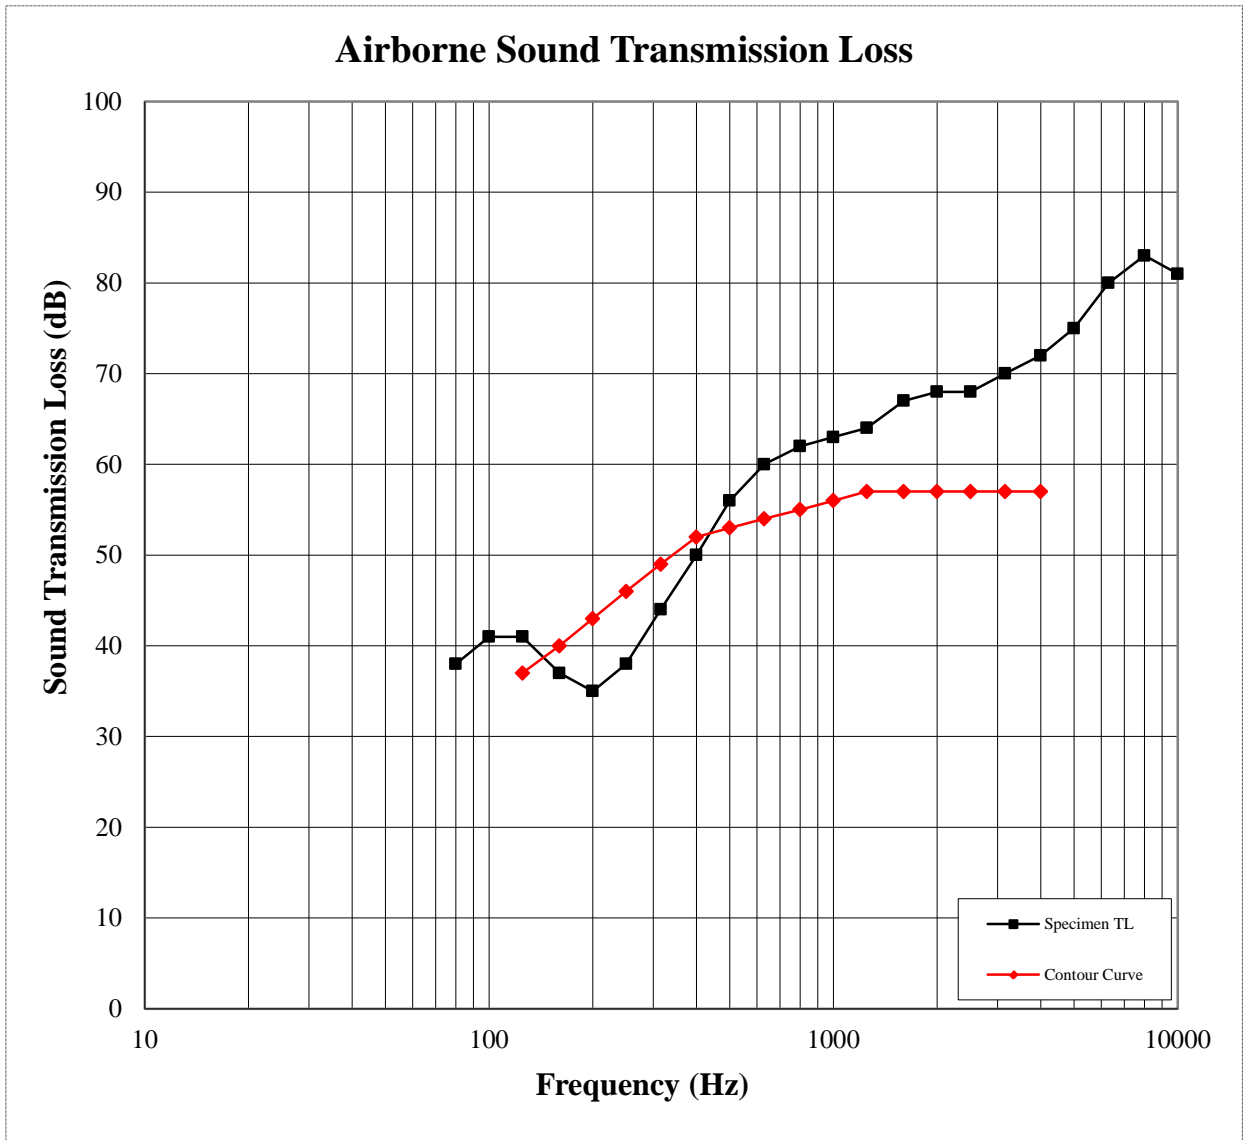
AIRBORNE SOUND TRANSMISSION LOSS ASTM E 90

Test Date	10/03/14
Data File No.	E1551.05
Client	Regupol America
Description	7 mm Ceramic Tile, 10 mm Regupol Sonus Rubber Underlayment, 152 mm Concrete Slab
Specimen Area	10.98 m ²
Technician	Leeland S. Hoover

STC Rating **53** *(Sound Transmission Class)*
Deficiencies **26** *(Sum of Deficiencies)*

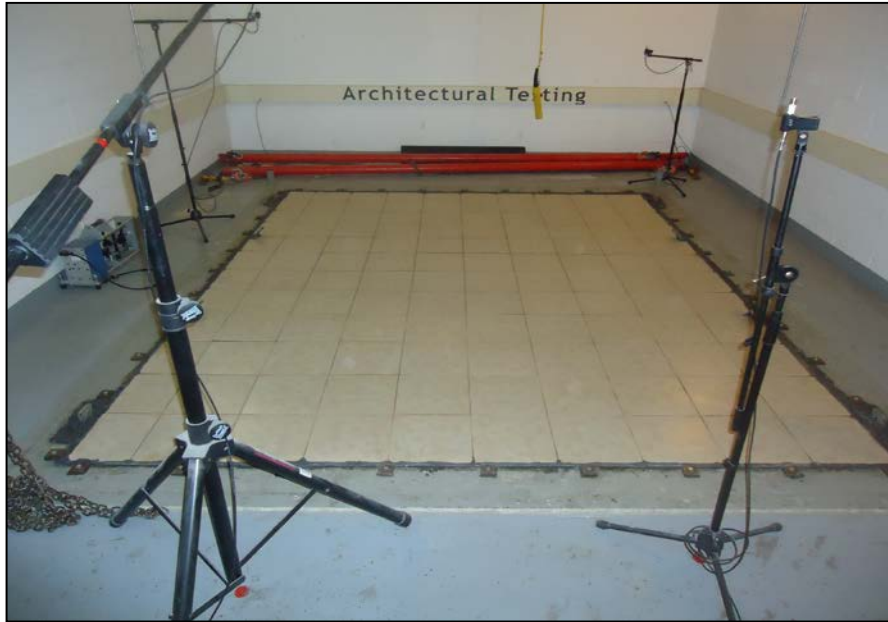
Source Room View of Test Specimen Installation

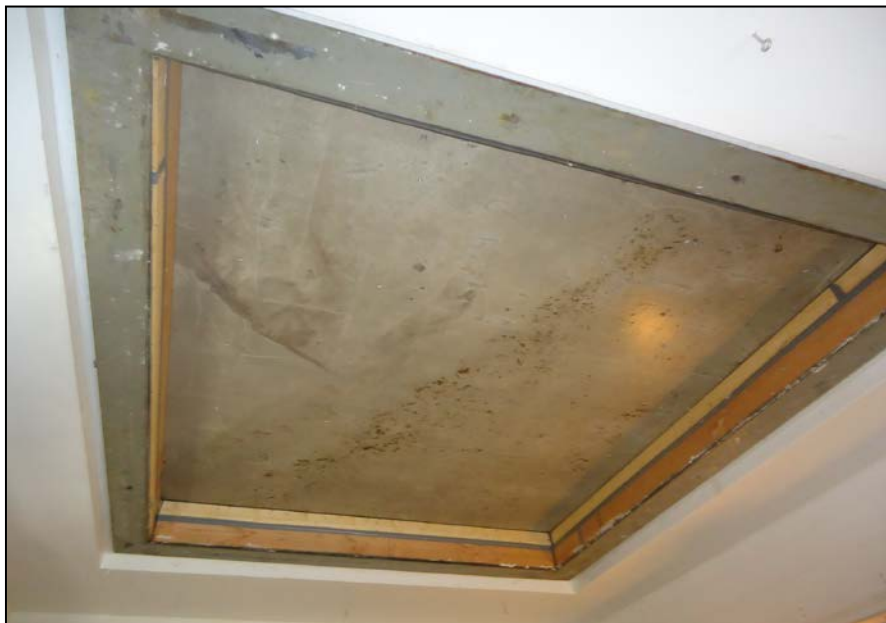
Receive Room View of Test Specimen Installation
