E1551.08-113-11-R0
ACOUSTICAL PERFORMANCE TEST REPORT
ASTM E 90 AND ASTM E 492

REGUPOL AMERICA

Series/Model: 10 mm Regupol Sonus

Specimen Type: Floor/Ceiling Assembly

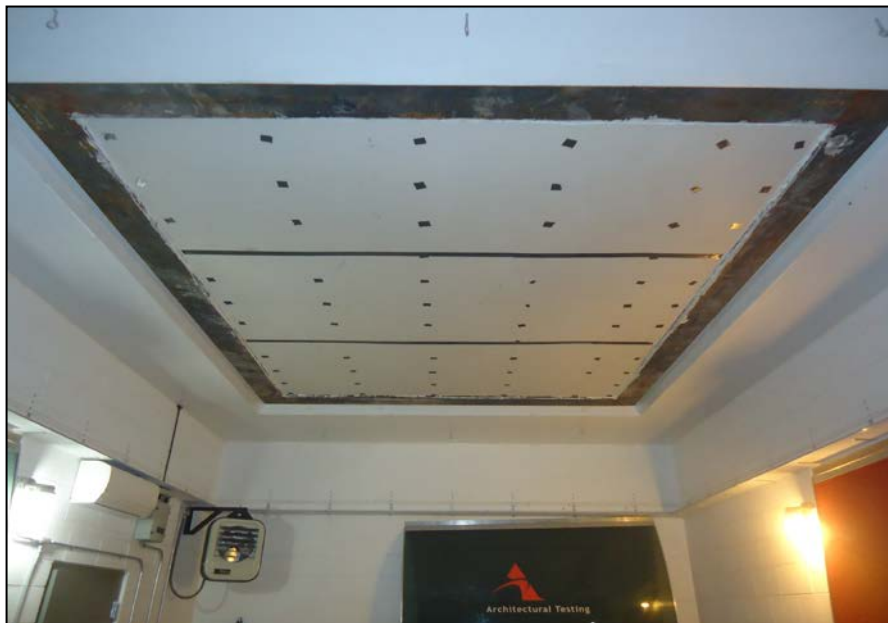
Receive Room View of Test Specimen Installation

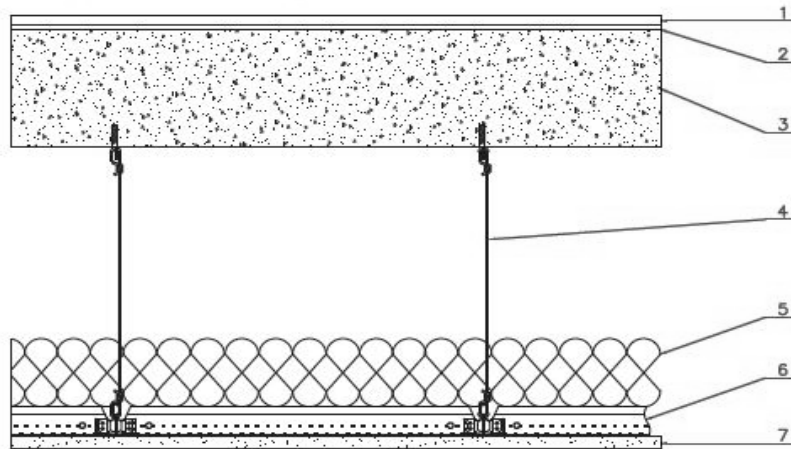
Drawings

- 1-Floor topping
- 2-Underlayment
- 3-Concrete Slab
- 4-Hanger Wire
- 5-Insulation
- 6-Ceiling Grid
- 7-Ceiling
