E1551.03-113-11-R0 ACOUSTICAL PERFORMANCE TEST REPORT ASTM E 492 AND ASTM E 2179

REGUPOL AMERICA

Series/Model: 10 mm Regupol Sonus Rubber Underlayment

Specimen Type: Floor/Ceiling Assembly

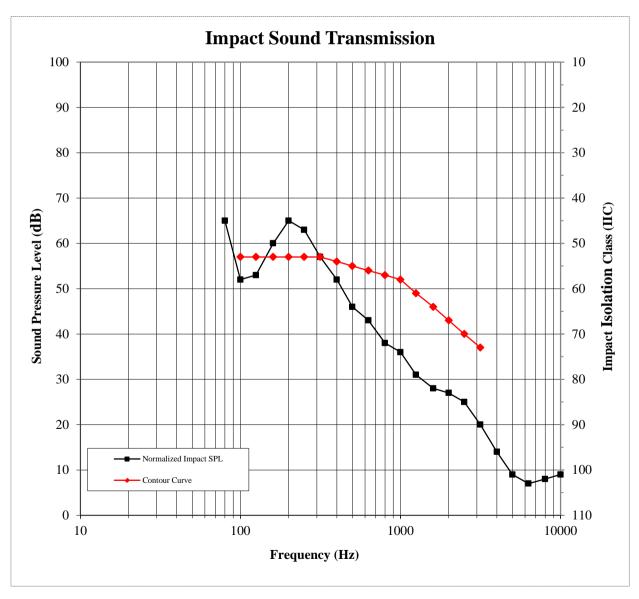
IMPACT SOUND TRANSMISSION ASTM E 492

| Test Date | 09/26/14 |
|---|---|
| Description | 11.92 mm Hardwood Flooring, 10 mm Regupol Sonus Rubber Underlayment, 152 mm Concrete slab |

IIC Rating55(Impact Insulation Class)Deficiencies17(Sum of Deficiencies)

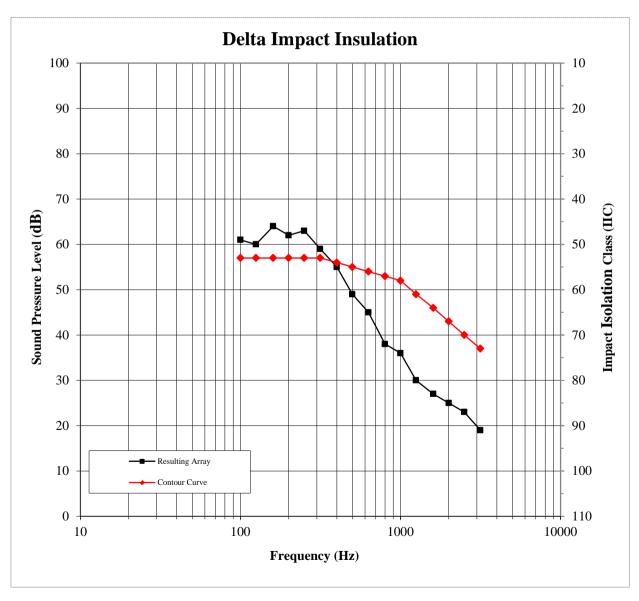
DELTA IMPACT INSULATION

| Test Date | 09/26/14 |
|---|---|
| Description | 11.92 mm Hardwood Flooring, 10 mm Regupol Sonus Rubber Underlayment, 152 mm Concrete slab |

ΔIIC Rating 27 (Delta Impact Insulation Class)

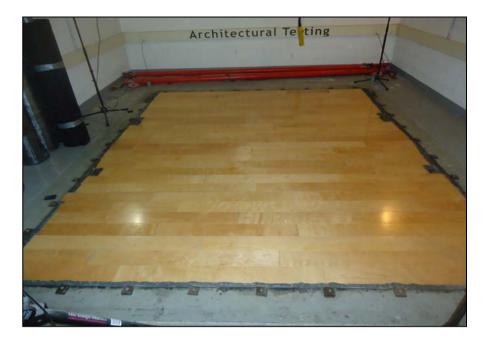
Source Room View of Test Specimen Installation

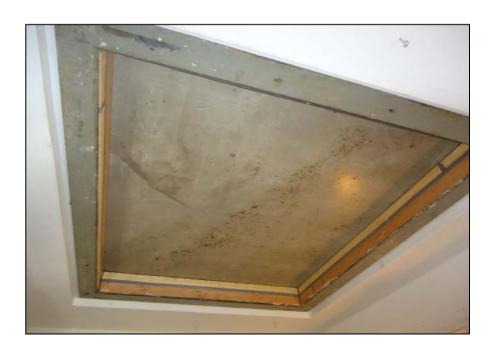
Receive Room View of Test Specimen Installation
