# REGUPOL AMERICA

# TEST REPORT

ASTM E90 AND ASTM E492 TESTING ON 10MM REGUPOL SONUS SOUND CONTROL UNDERLAYMENT UNDER CERAMIC TILE

I7419.01-303-11-R0

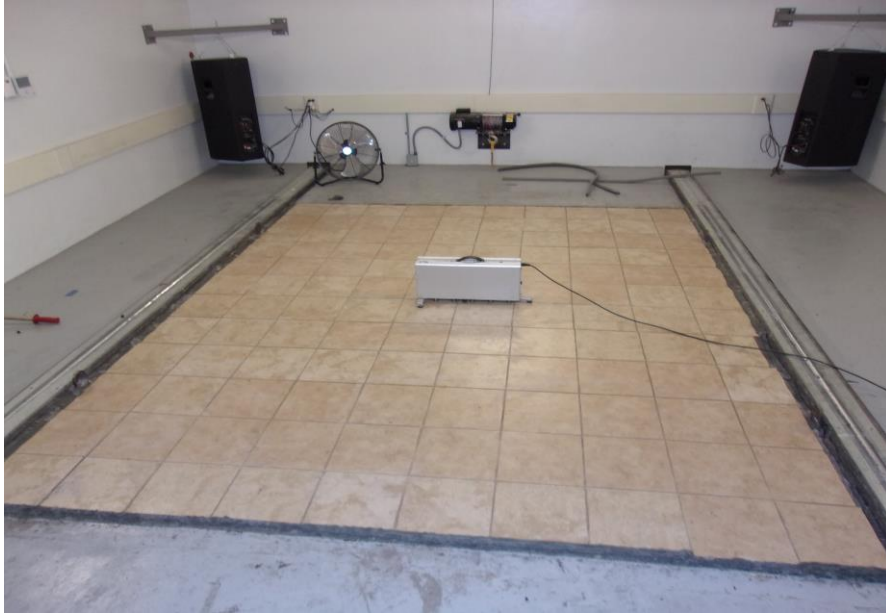
**Photo No. 1**

**Source Room View of Test Specimen Installation**

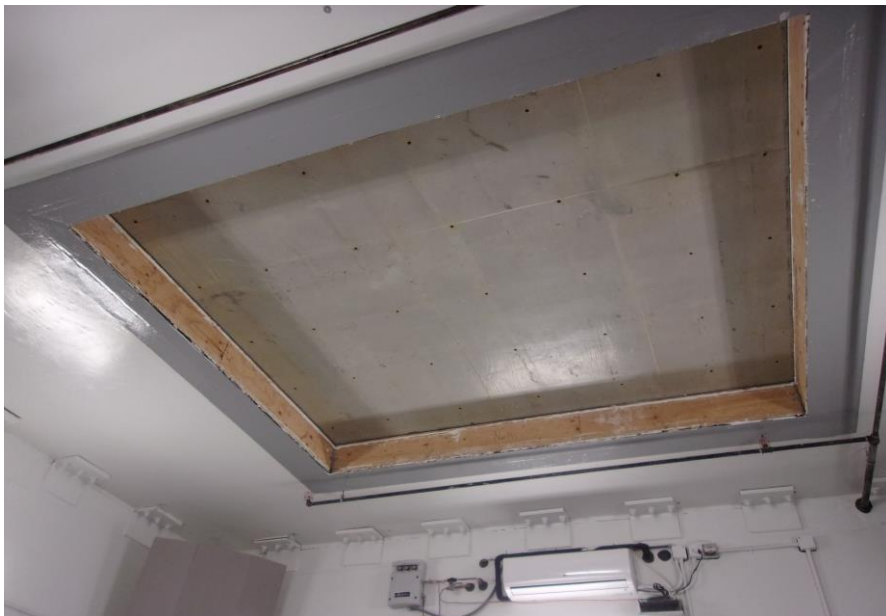
**Photo No. 2**

**Receive Room View of Test Specimen Installation**
